Technical Tips and Tricks |

AlliedWare Plus™ Managed Layer 3 Switches

This document contains useful technical tips and tricks for AlliedWare Plus Managed Layer 3 Switches.

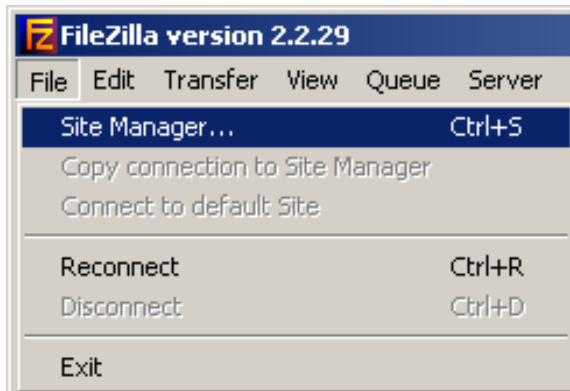
Within Filezilla, you need to create an FTP site definition that uses SFTP to connect to your switch.

1. Select **File > Site Manager...**

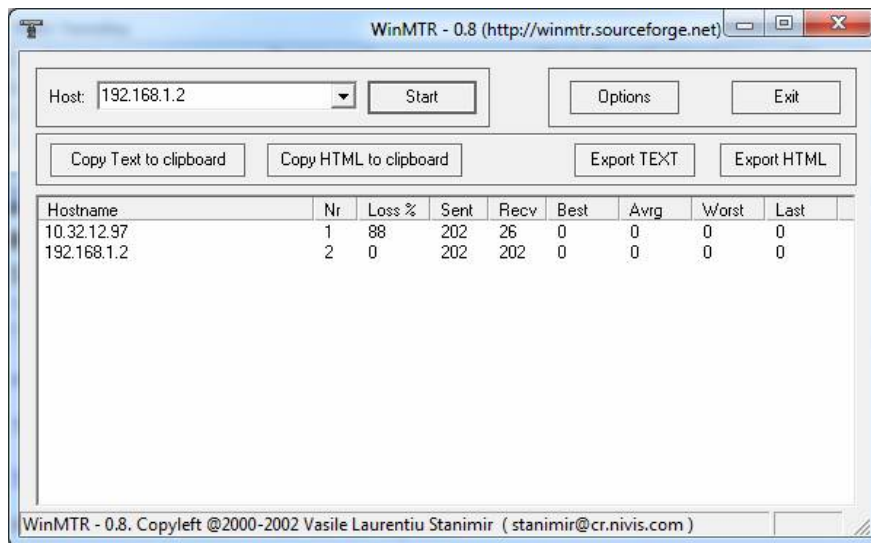
2. When we run this test (ICMP packets at 100ms interval), MTR to 192.168.1.2 shows

enormous packet loss:

3. MTR sends two frames every 100ms. These are ICMP echo requests, destined for 192.168.1.2. One has a TTL of 1 and the other has a TTL of 2.
4. The packet with a TTL of 2 reaches its destination and an ICMP echo reply is sent. This is correct.
5. The packet with a TTL of 1 reaches the AlliedWare Plus switch (10.32.12.97) and the TTL expires, so the switch sends back an ICMP Time-to-live Exceeded message. This is also correct.

However, the Linux kernel employs ICMP rate limiting for certain ICMP packets. This means that only around 1 in 10 TTL expired packets will actually result in an ICMP Time-to-live Exceeded message in this scenario. This explains why MTR reports about 88% loss to the SwitchBlade x908.
